NRL Memorandum Report 2196

## Damage Analysis of Wire Rope From a 34-Month Ocean Mooring

October 1970

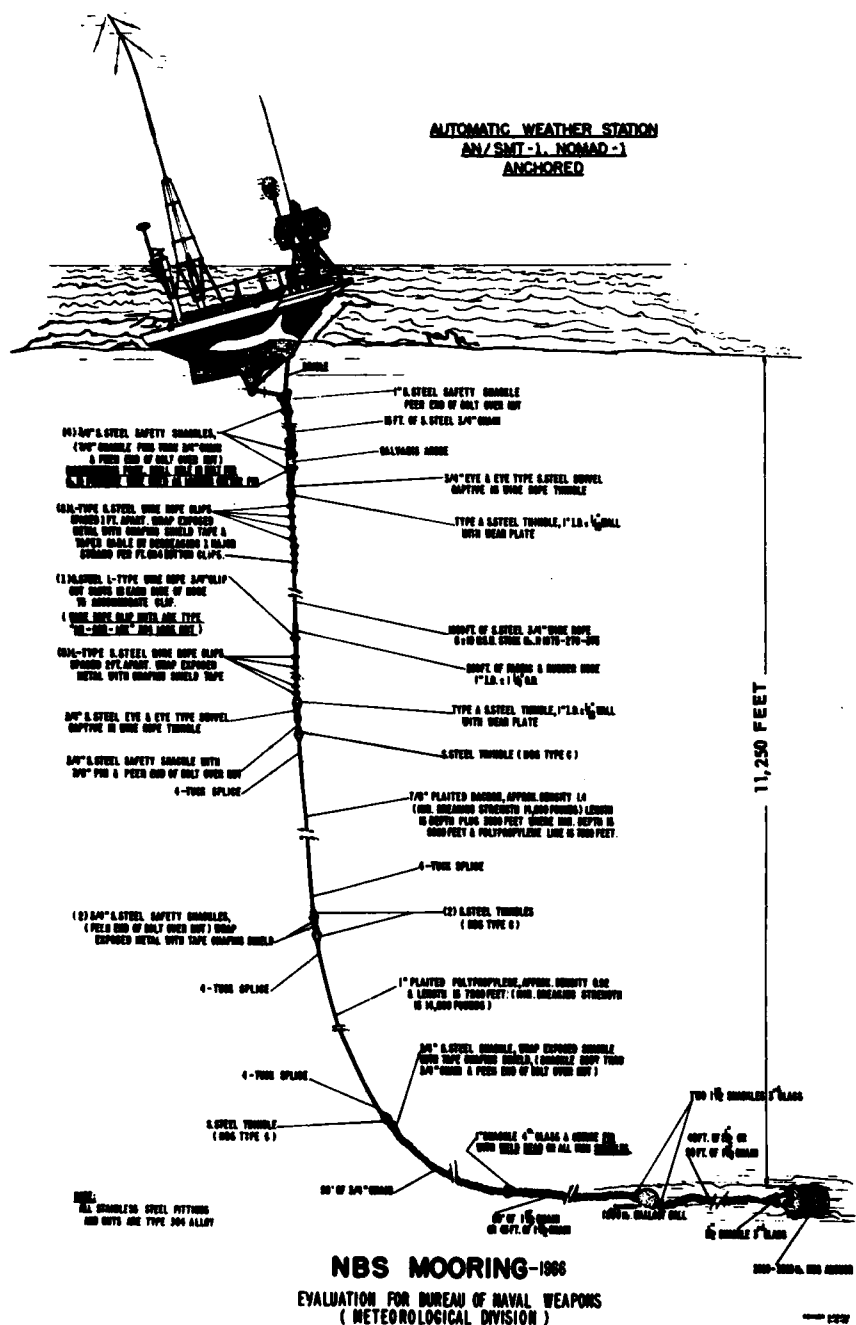
Reference is made to the drawing of the general NOMAD System in Fig. 1. It is important to obtain some idea of the size and geometry of this system. If instructions on the drawing are followed to obtain the length of the composite line from buoy to anchor, this length (23,000 feet) will be found to approximate twice the depth of the installation (11,250 feet). Thus if the mooring line could be straightened by forcing the buoy to a maximum far-left position, it would assume a minimum angle of  $30^{\circ}$  with the surface of the sea. In practice this condition cannot be reached because of the gravitational forces which act upon the massive components near the extremities of the line.

An interesting point can be made about the safety factor and the allowable design tensile force on the rope. In Fig. 1, a minimum break strength of 14,000 lb is specified for the dacron line. Assuming a safety factor of three, the allowable tension in this line, and an approximation to the tension in the lower end of the wire rope that was attached to it was 4670 lb. This tensile force in the wire rope might be increased by the weight of the 1000 feet of line ( $\sim$ 1000 lb) to some 5700 lb at the upper end of the rope; thus, the minimum design safety factor for the wire rope was about 9. The allowable static stresses in the wire rope were low, a fact which contributed to the long life of the installation.

Fig. 1 - The General NOMAD System. Several design changes were incorporated in the system which is analyzed in this report. Changes are noted on page 3.
